**RENOVATION OF THE KHANDEK
INTERMEDIATE SCHOOL
UNDER THE ECONOMIC SUPPORT FUND PROGRAM
YOUSEFIYA, IRAQ**

SUSTAINMENT ASSESSMENT

**SIGIR PA-08-136
APRIL 21, 2009**

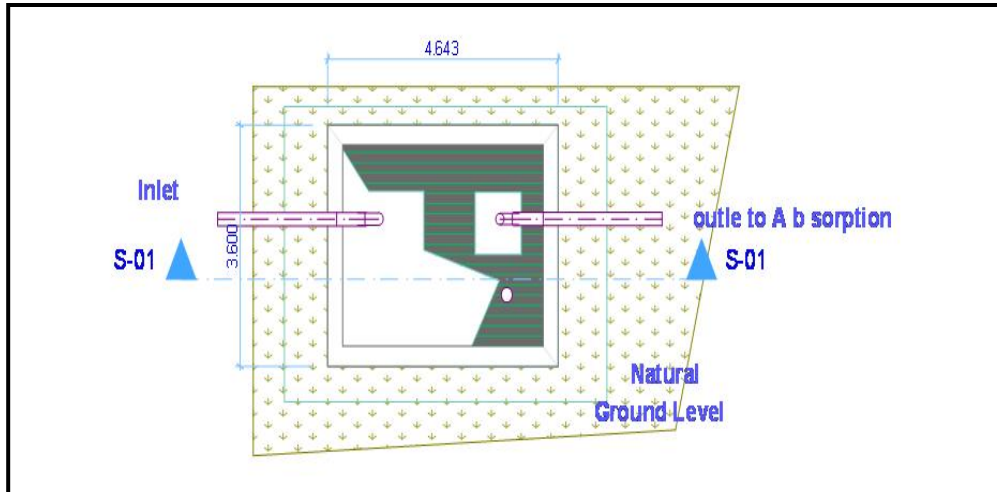
Figure 3. Septic tank plan (Courtesy of GRC)

The septic holding tank indicates that the outlet of the tank flows to an absorption area. The location and configuration of the absorption was not indicated in the design. It is unclear if this system is intended to treat sewage and promote absorption into the soil, or if the tank(s) function as holding tanks to be pumped out on a regular basis.

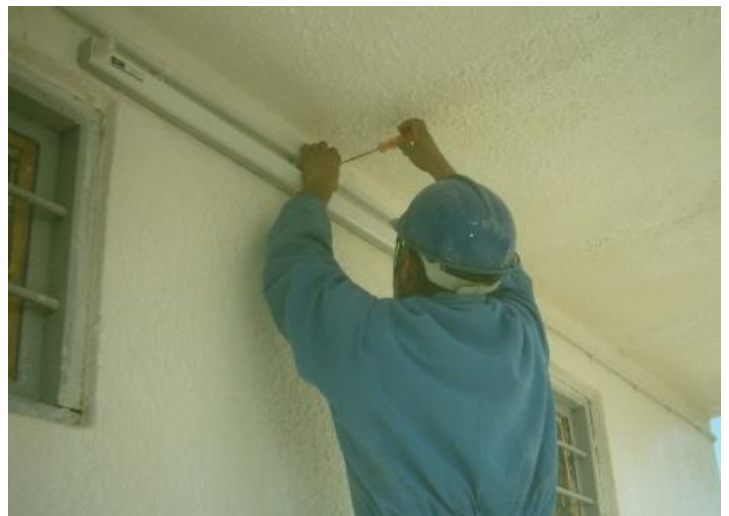
Site Photos 3 and 4 document various construction work activities at the school, such as the demolition of existing tiles, installation of new lighting, and new foundation and formwork construction.

Site Photo 4. New lighting installation (Courtesy of GRC)

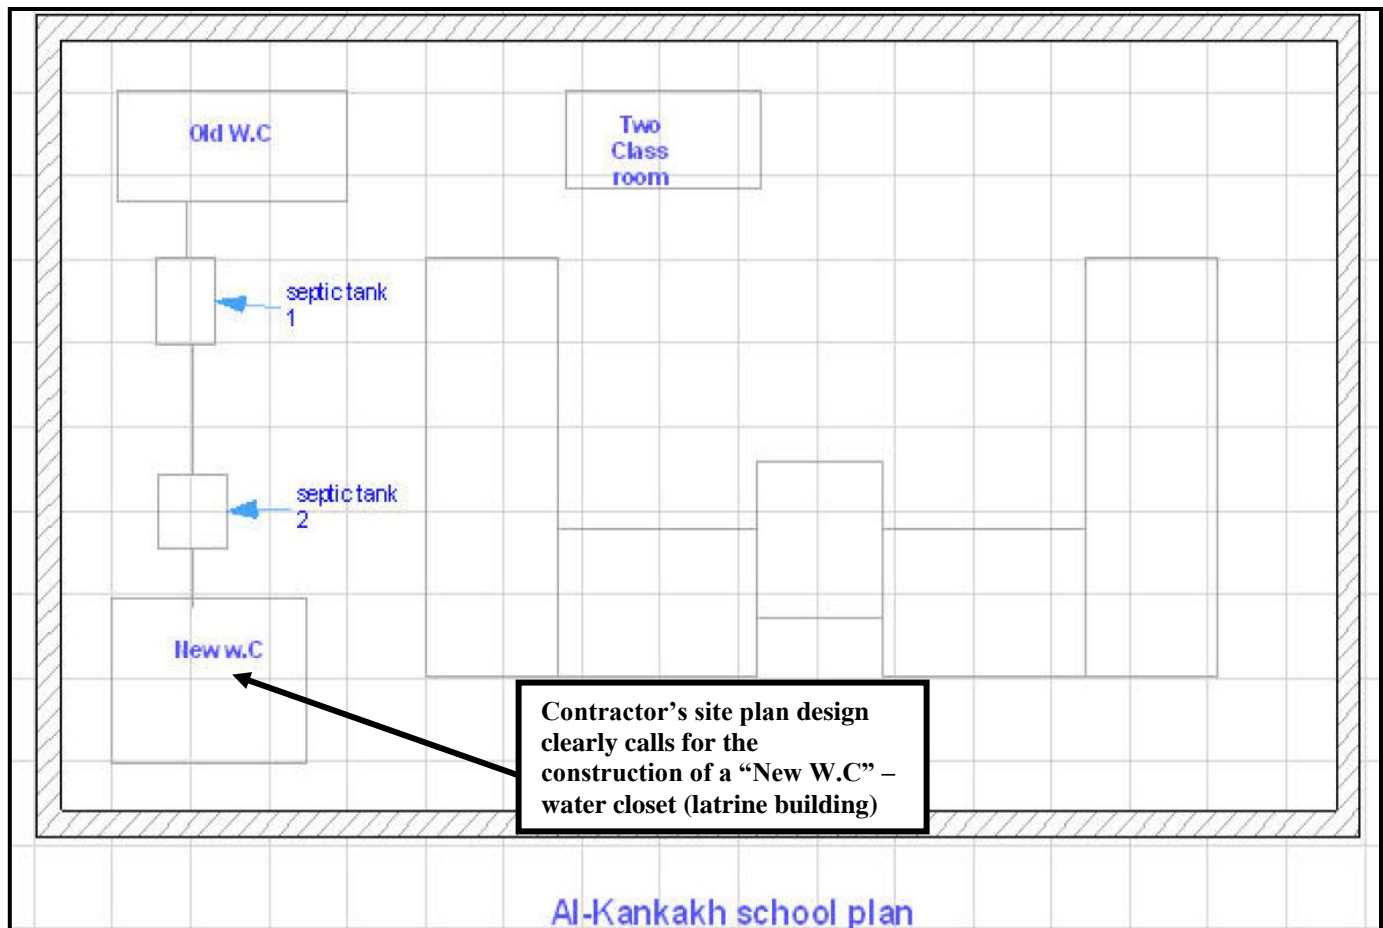
However, this statement is contradicted by the contractor's design submittals, which clearly indicated on the school's site plan "New W.C. [water closet]" (Figure 4). The design, which the contractor submitted to GRC for review and approval prior to construction, refutes the statement that this water closet/latrine building was the idea of the school master and not part of this contract.

Figure 4. Contractor's site plan submittal clearly showing the construction of a new water closet (latrine building) (Courtesy of GRC)
